# Berens Park

Berens Park is a very large sized community park that provides parking, soccer and ball fields, playground, miniature golf, benches, picnic table, restrooms and indoor meeting rooms. The main issues at this park are parking slopes are too steep, parking signs are in the wrong location or not provided, gaps are too wide, walkway running and cross slopes are too steep, walkway surface are in poor condition or sunken, abrupt transitions are too high, handrails are missing on a ramp, playground surface is uneven, an accessible swing is not provided, picnic table knee and clear floor space is not provided, a spring rider is mounted too high, standing height drinking fountain is not provided, trail surface is not accessible and trail head signs are not provided, door force is too high and or close too quickly, toilet paper dispenser is mounted too far from the toilet, protective covers are missing on shut-offs and drain pipes, and a grill does not provide a clear ground space. **Please Note:** When a **UD** is indicated, this is a Universal Design (**UD**) recommendation to enhance accessibility. The **UD** recommendation is not required to meet the minimum accessibility s

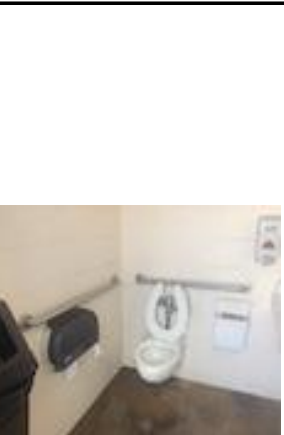
The all gender restroom by Field #2 toilet paper dispenser is mounted too far in front of the toilet at 11 inches.	ADAAG 604.7	Remount the toilet paper dispenser to be no lower than 15 inches, no higher than 48 inches AFF and a centerline of the double roll dispenser that is a minimum of 7 inches to a maximum of 9 inches in front of the toilet. If above the grab bar provide at least 12 inches clearance between the grab bar and the bottom of the toilet paper dispenser. Do not mount the toilet paper dispenser behind the side grab bar. <b>Recommendation:</b> It would be recommend to mount the toilet paper dispenser 1 1/2 inches minimum under the side grab bar and no lower than 15 inches AFF.	3		\$ 310.00
