# Eldridge Park

Eldridge Park is a very large sized neighborhood park that provides parking, recreation center, playgrounds, ballfield, soccer field, tennis courts, sledding hill, telephone, drinking fountain and walkways. The main issues at this park are parking slopes are too steep, parking signs are not at the proper locations or are missing, cross slopes and running slopes are too steep, some running slopes do not provide handrails, a canoe/kayak launch is not provided, a fishing pier is not provided, curb ramp slope is too steep, dog waste bags are mounted too high or are too far off the accessible route, accessible routes are missing, gaps are too wide, some walkway surfaces are in poor condition, a play panel does not provide a handle for operation, a portable toilet hand sanitizer and toilet paper dispenser are mounted too high, branches protrude, companion seating is not provided, and a wheelchair height drinking fountain is not provided. **Please Note:** When a **UD** is indicated, this is a Universal Design (**UD**) recommendation to enhance accessibility. The **UD** recommendation is not required to meet the minimum accessibility standards but it would be encouraged. W

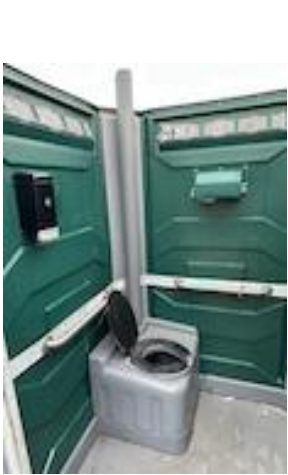
<p>The hand sanitizer is too high at 52 inches AFF.</p>	<p>ADAAG 308</p>	<p>Remount the hand sanitizer to provide a reach range no higher than 48 inches AFF for a forward reach over an obstruction no deeper than 20 inches or a side reach of 48 inches AFF over an object no deeper than 10 inches. If over an object or away from the accessible route provide a reach range no higher than 44 inches AFF maximum reach range over an object 20 inches to a maximum of 25 inches deep or a side reach of 46 inches AFF maximum over an object 10 inches to a maximum of 24 inches.</p>	<p><b>2</b></p>		<p>\$ 125.00</p>

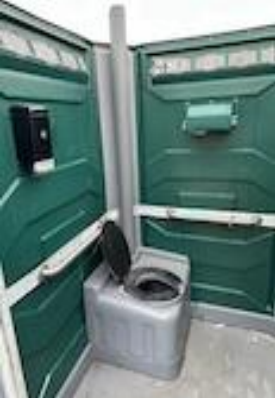
<p>The toilet paper dispenser is too high at 56 inches AFF.</p>	<p>ADAAG 604.7</p>	<p>Remount the toilet paper dispenser to be no lower than 15 inches, no higher than 48 inches AFF and a centerline of the double roll dispenser that is a minimum of 7 inches to a maximum of 9 inches in front of the toilet. If above the grab bar provide at least 12 inches clearance between the grab bar and the bottom of the toilet paper dispenser. Do not mount the toilet paper dispenser behind the side grab bar. <b>Recommendation:</b> It would be recommended to mount the toilet paper dispenser 1 1/2 inches minimum under the side grab bar and no lower than 15 inches AFF.</p>	<p><b>3</b></p>		<p>\$ 310.00</p>
