Glos Memorial Park

Glos Memorial Park is a medium sized park that provides walkways, drinking fountain, benches and a family memorial. The main issues at this park are cross slopes are too steep, drop-offs are too high, a standing height drinking fountain is not provided, and gaps are too wide. **Please Note:** When a **UD** is indicated, this is a Universal Design (**UD**) recommendation to enhance accessibility. The **UD** recommendation is not required to meet the minimum accessibility standards but it would be encouraged. If used in this report, the letters, **AFF** stand for above finished floor.

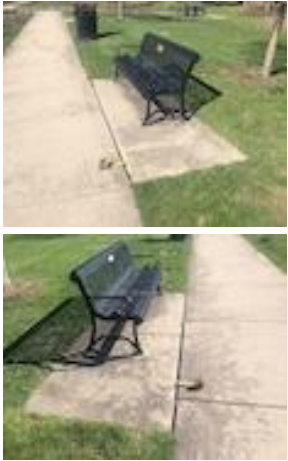
The two benches have gaps too wide at 1 inch at each companion seating area.	ADAAG 302.3	Fill in or replace section of walkway to provide a flush transition or an opening no greater than 1/2 inch.	1		\$ 600.00
