Hub at Berens Park

The Hub is a building located in Berens Park that provides multi-use building, restrooms, baby changing table and coat hooks. The main issues at this building are door force is too high and/or closes too quickly, toilet paper dispenser is mounted too close to the grab bar, coat hooks are mounted too high, feminine napkin disposal is mounted too far from the toilet, stall door is not self closing or provide handles, baby changing table is mounted too high, . **Please Note:** When a **UD** is indicated, this is a Universal Design (**UD**) recommendation to enhance accessibility. The **UD** recommendation is not required to meet the minimum accessibility standards but it would be encouraged. If used in this report, the letters, **AFF** stand for above finished floor.

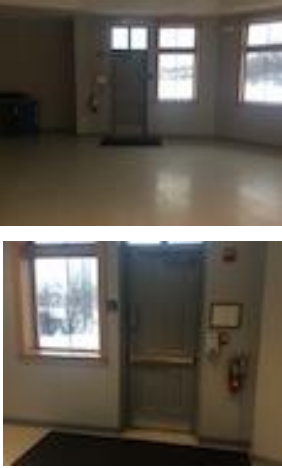
<p>The multi-purpose room exterior doors both have an opening force too high at 10 lbs.</p>	<p>IAC 404.2.9</p>	<p>Adjust the closer so the door opening force is no heavier than 8.5 lbs. to open and takes a minimum of 5 seconds to close or provide an automatic door opener at the door.</p>	<p>1</p>		<p>\$ 250.00</p>
