# Kies Recreation Center

Kies Recreation Center is part of Centennial Park that provides parking, gym, classrooms and restrooms. The main issues at this building are door force is too high, sink knee clearance is too low, mirrors are mounted too high, stall doors are not self closing, rear grab bar is in the wrong location, signage is on the wrong wall, toilet paper dispenser is too close to the toilet, hangers are too high, . **Please Note:** When a **UD** is indicated, this is a Universal Design (**UD**) recommendation to enhance accessibility. The **UD** recommendation is not required to meet the minimum accessibility standards but it would be encouraged. If used in this report, the letters, **AFF** stand for above finished floor.

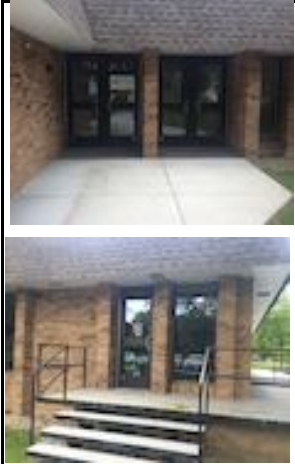
<p>There are 4 emergency exit door with opening force too high at 12 lbs.</p>	<p>IAC 404.2.9</p>	<p>Adjust the closer so the door opening force is no heavier than 8.5 lbs. to open and takes a minimum of 5 seconds to close or provide an automatic door opener at the door.</p>	<p><b>1</b></p>		<p>\$ 125.00</p>
