Marjorie Davis Park

Marjorie Davis Park is a medium sized neighborhood park that provides parking, playground, picnic table, walkways, green space, garden, basketball court and portable toilet. The main issues at this park are parking space slope is too steep, dog waste bags are mounted too high, walkway cross slopes are too steep or uneven from tree roots, no accessible swing is provided, an accessible route is not provided in the garden or a raised garden bed is also not provided, bleachers do not provide companion seating space, and the hand sanitizer and toilet paper dispenser is mounted too high.
Please Note: When a **UD** is indicated, this is a Universal Design (**UD**) recommendation to enhance accessibility. The **UD** recommendation is not required to meet the minimum accessibility standards but it would be encouraged. If used in this report, the letters, **AFF** stand for above finished floor.

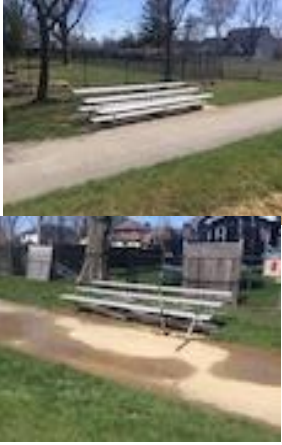
<p>The two sets of bleachers do not provide companion seating.</p>	<p>ADAAG 221.2.1 & 802.1</p>	<p>Provide the appropriate number of wheelchair spaces (30 inches X 48 inches space) per total number of seats (\$375 per space) with a slope of 2% in all directions. Connect this wheelchair space to the accessible route.</p>	<p>2</p>		<p>\$ 1,500.00</p>
