Kid Safety Town

Kid Safety Town is a small sized area that provides kids to ride their bikes and learn safety rules of the road in a safe setting. The main issues at this park are gaps are too wide, picnic tables do not provide knee clearances, abrupt transition are too high, curb ramp slopes are too steep, drinking fountain does not provide the proper clear floor space, and benches do not provide companion seating. **Please Note:** When a **UD** is indicated, this is a Universal Design (**UD**) recommendation to enhance accessibility. The **UD** recommendation is not required to meet the minimum accessibility standards but it would be encouraged. If used in this report, the letters, **AFF** stand for above finished floor.

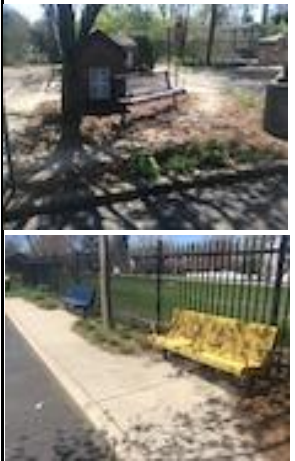
<p>The three benches do not provide companion seating.</p>	<p>IAC 1011.2.1</p>	<p>At two benches, provide a clear ground space of at least 36 inches by 48 inches positioned near the bench with one side adjoining the walkway. The clear ground space should have a slope no steeper than 2% in all directions. The clear ground space should not overlap the accessible route or another clear ground space.</p>	<p>2</p>		<p>\$ 750.00</p>
