Sugar Creek Golf Course

Sugar Creek Golf Course is a public golf course that provides parking, restrooms, bar area and equipment shop. The main issues at this facility are parking spaces have slope issues, parking signs are not mounted at the center head, inline curb ramps are not provided, gaps are too wide, abrupt transition too high, benches do not provide enough space for accessible golf carts, portable toilet is not of an accessible design, door force is too high and/or close too quickly, signage is not provided to offer assistance in the product shop, mirrors are mounted too high, coat hooks are mounted too high, stall door inside handles are not provided, toilet paper dispensers are mounted to the side, grab bars are mounted too high, a cleaner and plunger are in the clear floor space of the toilet, pipe protection is not provided, a standing height drinking fountain is not provided, a counter is mounted too high. **Please Note:** When a **UD** is indicated, this is a Universal Design (**UD**) recommendation to enhance accessibility. The **UD** recommendation is not required to meet the minimum accessibility standards but it would be encouraged. If used in this report, the

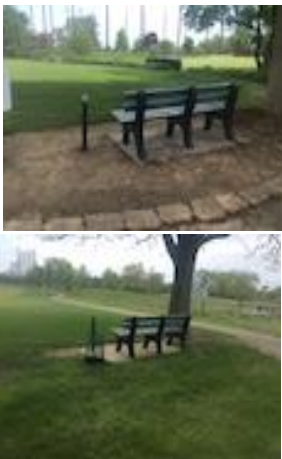
| Photo | Barrier | ADAAG/IAC | Solution | Priority | By Whom | Projected Cost | Projected Date | Action Taken |
|---|--|---|--|---|---|---|---|---|
| | <p>The space at the side of the bench at Hole #1 and Hole #8 do not provide the space for an accessible golf cart.</p> | <p>ADAAG 1006</p> | <p>Remove the stand post to provide the spacing necessary next to the benches to allow an accessible golf cart to pull up next to the bench. A minimum 4 foot space is recommended.</p> | <p>2</p> | | <p>\$ 1,000.00</p> | | |
