# Wagner Recreation Center

The Wagner Recreation Center provides parking, restrooms, multi-purpose classrooms and gymnastics. The main issues at this facility are door force is too high and/or closes too quickly, stall doors are not self closing or provide handles, coat hooks are too high, toilet paper dispensers are not in proper locations feminine napkin disposals are too far from the toilet, mirrors are not at proper heights, baby changes tables are mount too high or are an older inaccessible model, grab bars are mounted too high, signage is mounted too high or in the wrong location, hand dryers protrude, a standing height drinking fountain is not provided, a proper clear floor space is not provided at a drinking fountain, accessible route is not provided, no clear maneuvering space is provided at a door, a sink is not accessible, no accessible restroom for children is provided, mats are too light and a tripping hazard, and no proper emergency egress is provided. **Please Note:** When a **UD** is indicated, this is a Universal Design (**UD**) recommendation to enhance accessibility. The **UD** recommendation is not required to meet the minimum accessibility standards but it wou

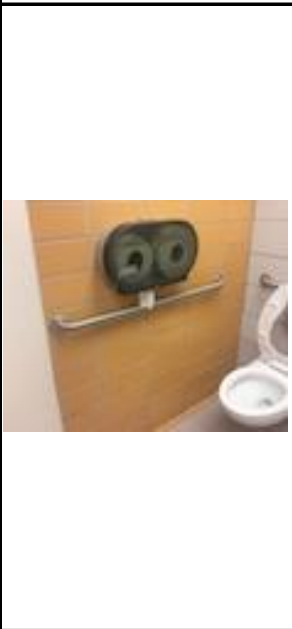
<p>The other men's restroom near the entrance toilet paper dispenser is mounted only 3 inches above the side grab bar.</p>	<p>ADAAG 604.7</p>	<p>Remount the toilet paper dispenser to be no lower than 15 inches, no higher than 48 inches AFF and a centerline of the double roll dispenser that is a minimum of 7 inches to a maximum of 9 inches in front of the toilet. If above the grab bar provide at least 12 inches clearance between the grab bar and the bottom of the toilet paper dispenser. Do not mount the toilet paper dispenser behind the side grab bar. <b>Recommendation:</b> It would be recommend to mount the toilet paper dispenser 1 1/2 inches minimum under the side grab bar and no lower than 15 inches AFF.</p>	<p><b>3</b></p>		<p>\$ 310.00</p>

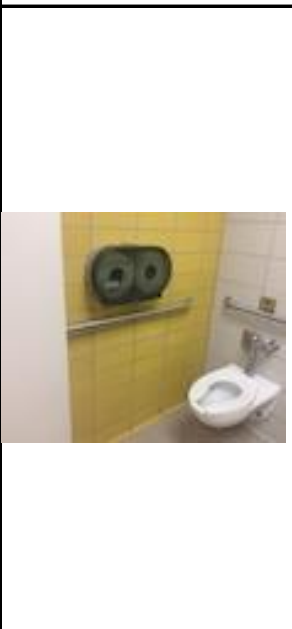
<p>The women's restroom near the children's area has the toilet paper dispenser mounted only 3 1/2 inches above the side grab bar.</p>	<p>ADAAG 604.7</p>	<p>Remount the toilet paper dispenser to be no lower than 15 inches, no higher than 48 inches AFF and a centerline of the double roll dispenser that is a minimum of 7 inches to a maximum of 9 inches in front of the toilet. If above the grab bar provide at least 12 inches clearance between the grab bar and the bottom of the toilet paper dispenser. Do not mount the toilet paper dispenser behind the side grab bar. <b>Recommendation:</b> It would be recommend to mount the toilet paper dispenser 1 1/2 inches minimum under the side grab bar and no lower than 15 inches AFF.</p>	<p><b>3</b></p>		<p>\$ 310.00</p>

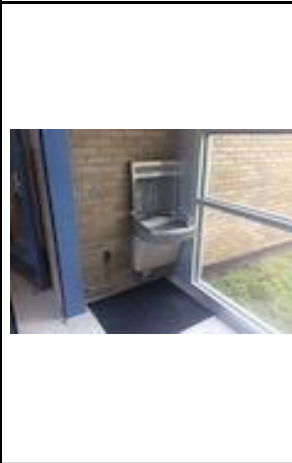
<p>The gymnastics center drinking fountain is mounted too low at 25 inch knee clearance.</p>	<p>ADAAG 211 &amp; ADAAG 602</p>	<p>Provide another individual drinking fountain at a standing height between 38 inches minimum to 43 inches maximum to the spout. Option: Remove existing drinking fountain and install a single Hi-Lo drinking fountain that provides a wheelchair accessible fountain with a spout at 36 inches maximum and a standing drinking fountain with a height between 38 inches minimum and 43 inches maximum. The toe clearance should be a minimum of 9 inches.</p>	<p><b>4</b></p>		<p>\$ 2,875.00</p>
