Wild Meadows Trace

Wild Meadows Trace is a long linear park that provides walkways, picnic shelter, drinking fountain and signage. The main issues at this park are a gap is too wide, elements are too far off the accessible route, not enough clear floor space is provided at the drinking fountain, accessible routes are missing, companion seating is not provided, . **Please Note:** When a **UD** is indicated, this is a Universal Design (**UD**) recommendation to enhance accessibility. The **UD** recommendation is not required to meet the minimum accessibility standards but it would be encouraged. If used in this report, the letters **AF** stand for above finished floor.

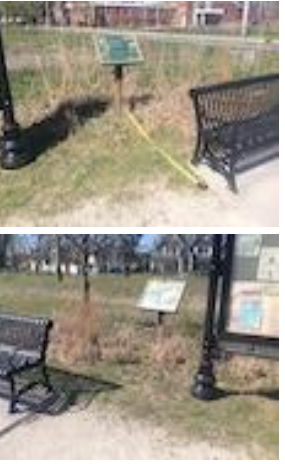
No accessible route is provided up to the benches.	IAC 1011	Provide a new accessible route with a running slope no steeper than 5% and a cross slope no steeper than 2% and a minimum clear width of 36 inches and connect to the companion seating of the bench.	2		\$ 1,200.00
