Wilder Park

Wilder Park is a very large sized neighborhood park that provides parking, walkways, picnic areas, grills, playground, mansion and Conservancy. The main issues at this park are abrupt transition are too high, gaps too wide, cross slope and running slope is too steep, parking space slopes are too steep, parking signage not at the center head, ramps slopes too steep, do not provide handrails or edge protection, clear floor space at benches are blocked, accessible routes are missing, picnic table do not provide accessible designs or provide accessible surfaces, grills do not provide clear ground space and are mounted too high, gutter slopes are too steep, curb ramp is missing, and dog waste bags are too high. **Please Note:** When a **UD** is indicated, this is a Universal Design (**UD**) recommendation to enhance accessibility. The **UD** recommendation is not required to meet the minimum accessibility standards but it would be encouraged. When engineered wood fiber is used, provide a regular maintenance of the surface to keep it in compliance with appropriate accessibility slopes. If used in this report, the letters, **AFF** stand for above finished floor.

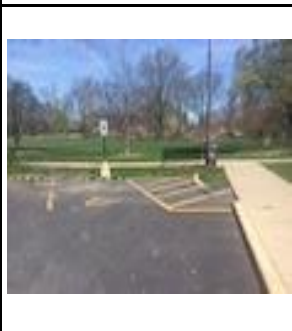
<p>The parking at the Conservancy parking lot closes to the picnic area has parking with a running slope up to 4.4%.</p>	<p>ADAAG 502.4</p>	<p>Regrade the parking spaces to be no steeper than 2% in all directions.</p>	<p style="text-align: center;">1</p>		<p>\$ 1,275.00</p>
