Wilder Recreation Center

Wilder Recreation Center is a facility that provides restrooms and a preschool area. The main issues at this building are door force is too high and/or closes too quickly, door clear opening is too narrow, a toilet is too far from the stall wall, a rear grab bar is not provided, side grab bar is mounted too high, toilet paper dispenser is mounted too close to the toilet, stall door is not self closing or provide an inside handle, faucet shuts-off too quickly, rear grab bar does not provide the proper centerline, clearance for fingers are not provide at a side grab bar, and a hand dryer protrudes. **Please Note:** When a **UD** is indicated, this is a Universal Design (**UD**) recommendation to enhance accessibility. The **UD** recommendation is not required to meet the minimum accessibility standards but it would be encouraged. If used in this report, the letters, **AFF** stand for above finished floor.

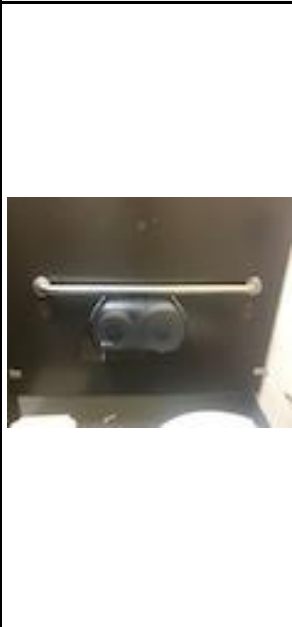
<p>The men's restroom side grab bar is mounted too high at 38 inches AFF.</p>	<p>ADAAG 609.4</p>	<p>Remount the grab bars to be between 33 inches to 36 inches AFF to the top of the grab bars.</p>	<p>3</p>		<p>\$ 400.00</p>
